## SERVICE BULLETIN

**APPLICABILITY:** Legacy, Impreza and Forester Vehicles  
**SUBJECT:** Modification of Timing Belt Tensioner Bracket

**NUMBER:** 02-93-04  
**DATE:** 11/05/04

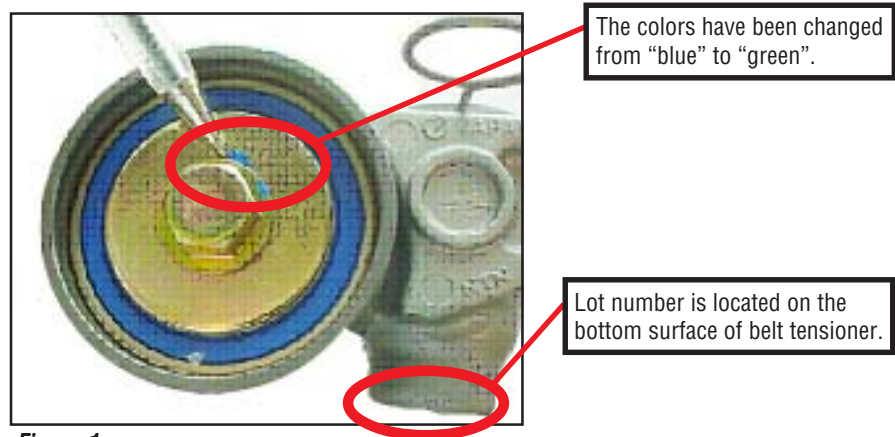
*Figure 1*

The color of the paint dot on the pulley bolt was changed from "Blue" to "Green" (see Figure 1)  
Lot number of belt tensioner: 020402 and after.

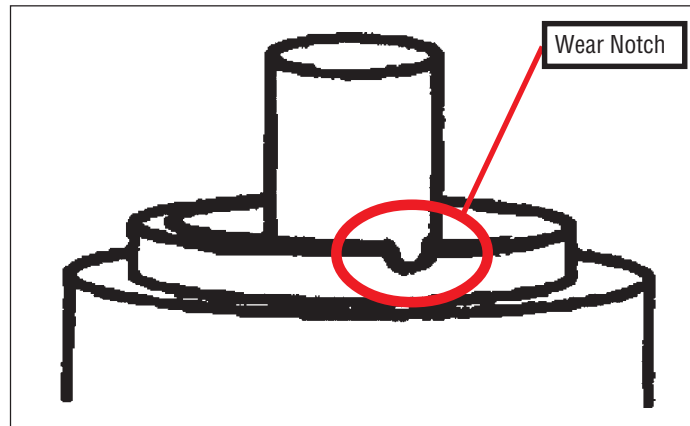
*Figure 2*

- (2) Confirm if the noise is coming from the upper portion of the timing belt tensioner by using a stethoscope. If noise can be heard it's either coming from the tensioner or bracket. Inspect the belt tensioner; if the cylinder body of the timing belt tensioner has a notch from wear (see Figure 2) the tensioner will need to be replaced.

- (3) If the engine number is 572570 for SOHC or 572928 for DOHC and after, replace the timing belt tensioner bracket.
- (4) If the engine number is 572570 for SOHC or 572928 for DOHC and before, check to see if the cylinder body of the timing belt tensioner has a wear notch. If so, replace the timing belt tensioner. If the cylinder body of the timing belt tensioner does not have a wear notch, replace the timing belt tensioner bracket.
