## SERVICE BULLETIN

**APPLICABILITY:** 2010MY and Later Legacy & Outback  
 2012MY Impreza  
 2006MY and later Tribeca

**NUMBER:** 12-134-12

**SUBJECT:** Washer Fluid Level Sensor Diagnostics

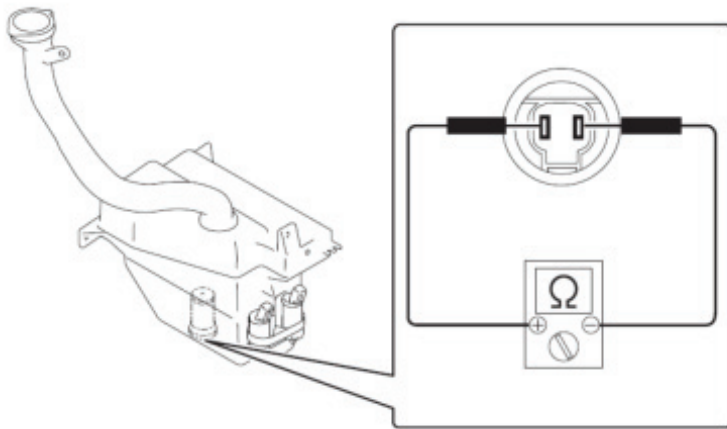
**Legacy and Impreza**

6. Using a DVOM, measure the resistance of the washer fluid level sensor as shown.

| Amount of Washer Fluid in the Tank | Resistance Standard |
| Empty (Indicator "ON") | Less than 10Ω |
| Fluid Remaining (Indicator "OFF") | 1 MΩ |

Is the measured resistance value within the standard?

- **YES** → Fluid level sensor operation is normal.
- **NO** → Replace the washer tank assembly as the fluid level sensor is not serviceable separately.  
Be sure to retain any re-usable fluid in a clean container.
