# SERVICE BULLETIN

**SUBARU CORPORATION**  
Customer Quality Dept.  
Japan.

Issued: Jun 8, 2023

| Subject: | <b>Release of Reprogramming Files (Ver. 12.0) for Gen4.0 CP1 (Cockpit Control Unit) 21-22MY OUTBACK</b> |

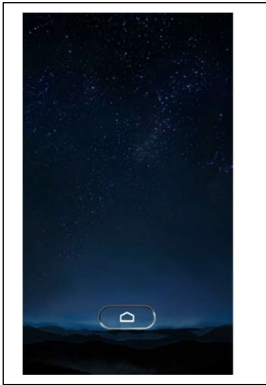
| No | Symptom to be improved |
|---|---|
| 5 | <p>Right after starting up, the CID displays only background without icons and no further operation can be done.</p> |

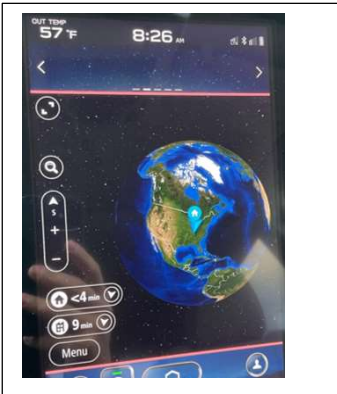
| No | Symptom to be improved |
|---|---|
| 15 | <p>Navigation map scale is changed to minimum (globe is displayed) itself. &lt;&lt;High grade only&gt;&gt;</p> |

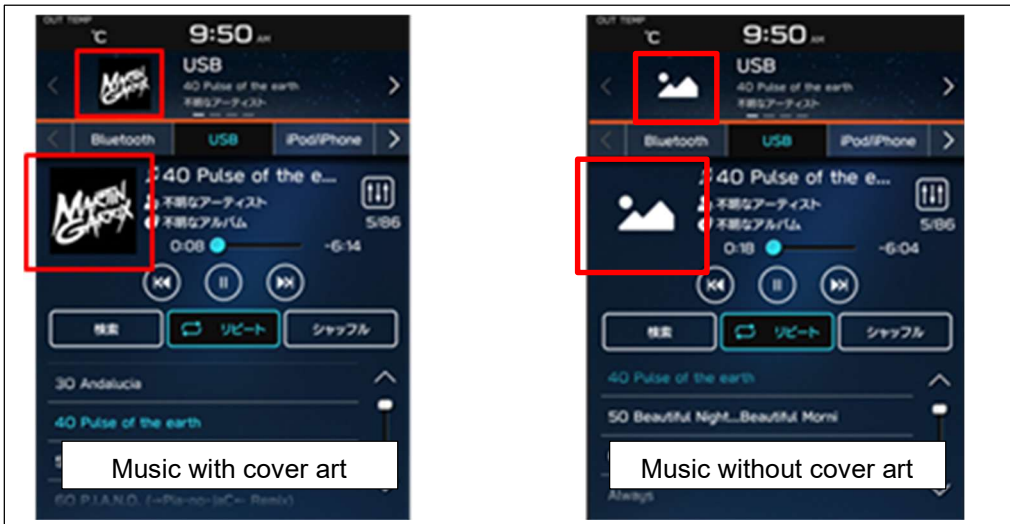
| No | Symptom to be improved |
|---|---|
| 17 | <p>Cover art of previous music is displayed when playing music without cover art in USB audio.</p> <p>It can occur when music with and without cover art is mixed and stored together a single USB.</p> <p>&lt;Reference&gt; Proper display of music with and without cover art.</p> <div data-bbox="280 465 1294 987"> </div> |

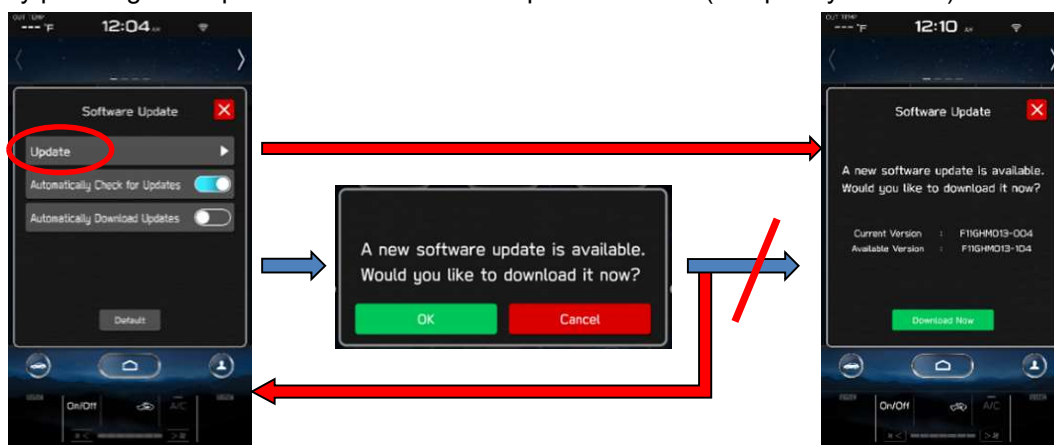
| No | Symptom to be improved |
|---|---|
| 19 | <p>When using FOTA service to update the software by selecting “Setting” &gt; “Software Update,” a message of “A new software update is available. Would you like to download it now?” is displayed but the downloading does not start after pressing “OK.”</p> <p>When this symptom occurs, it comes back to the “Software Update” screen. The downloading can be started by pressing the “Update” on the “Software Update” screen. (Temporary solution.)</p> <div data-bbox="236 1272 1294 1715"> </div> |

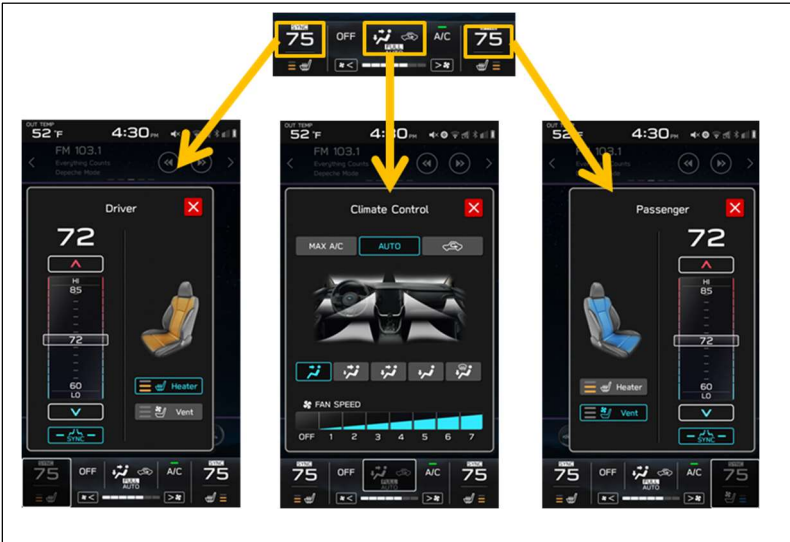
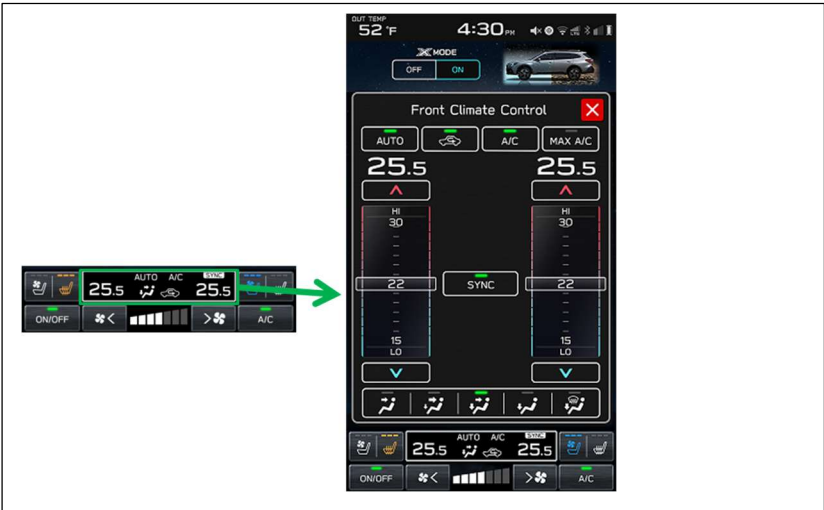
| No | Symptom to be improved |
|---|---|
| 23 | <p>Air conditioner control interface is changed to that of 23MY. &lt;&lt;High and Mid grades only&gt;&gt;</p> <p>Current ( -22MY) screen transition:</p> <p>23MY screen transition:</p> |
