## SERVICE BULLETIN

**APPLICABILITY:** 2003~06MY Forester  
**SUBJECT:** Sunroof Does Not Close Properly

**NUMBER:** 15-134-08R  
**DATE:** 11/10/08

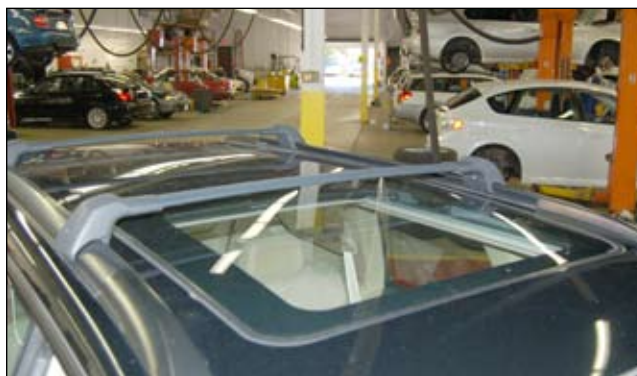
Before performing the repair, check to make sure there are no obstructions in the sunroof guide rail(s) and that there is no interference between the sunroof deflector and sunroof glass lid. Either one will cause improper sunroof operation.

Move the front roof rack cross bar to the rearward position (if equipped).

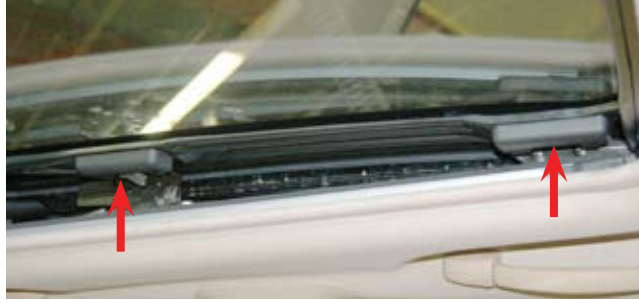
Fully close the sunroof glass lid using the sunroof switch or sunroof wrench. Fully open the sunroof shade.

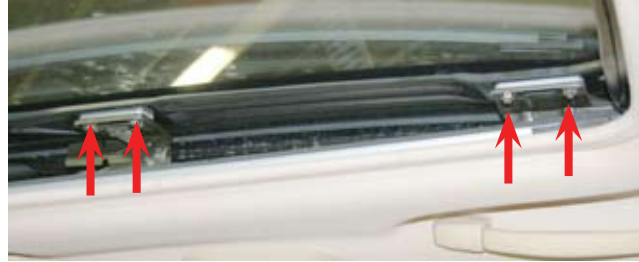
Remove the 4 lift bracket trim covers; there are 2 on each side.

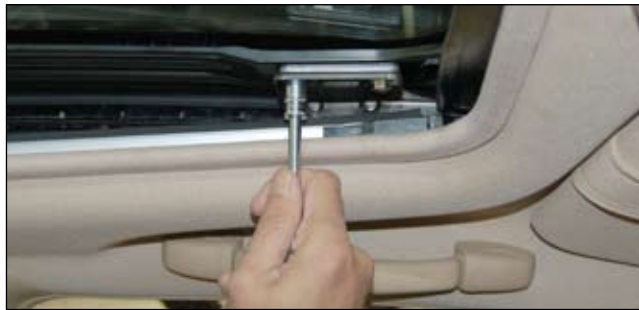
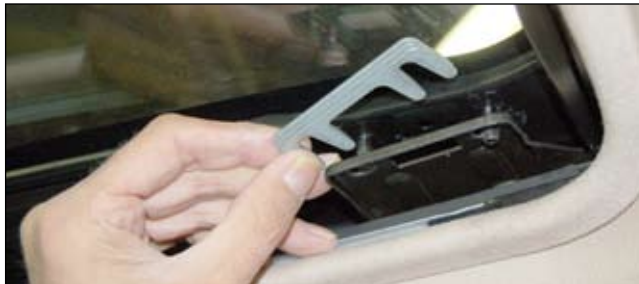
Remove the 8 nuts from the lift bracket; there are 4 on each side.

Remove the shims. Pay extra attention to the number of shims in each location. **Note:** At the end of the procedure the shims will need to be reinstalled in their original location to ensure proper glass height adjustment.

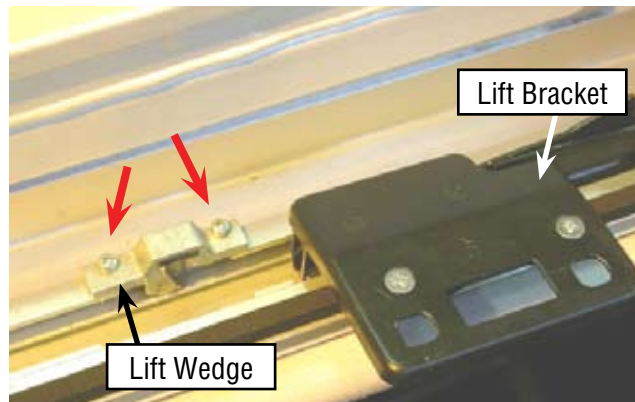
Using the sunroof switch or sunroof wrench, move the lift bracket approximately 4 inches towards the rear of the vehicle. Remove the 2 screws from the lift wedge on each side.

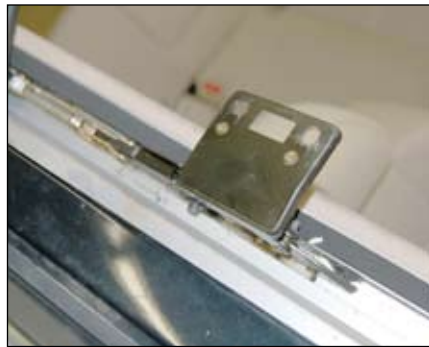
The repair kit contains a left and a right side white plastic spacer. Make sure to install spacers on the correct side.

**Note:** The lift bracket must be moved forward past the lift wedge opening to expose the area of where the spacers are to be installed.

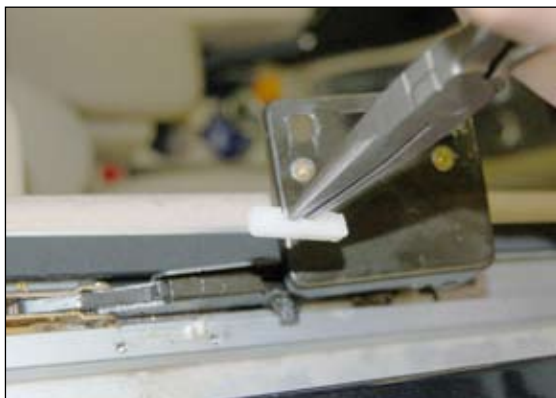
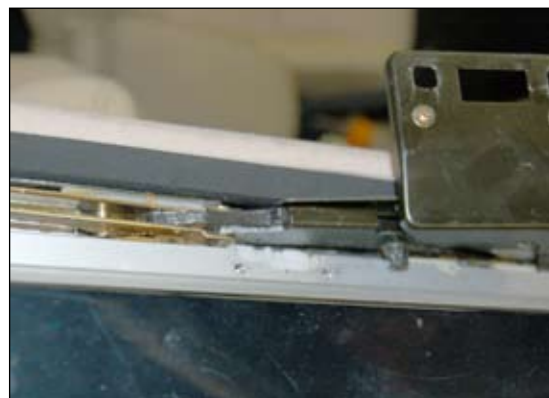
Align the edge of spacer and the rear edge of the opening of the lift wedge.

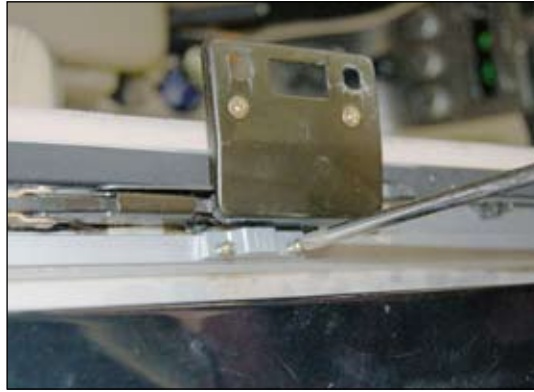
Insert the spacer into the opening of the lift wedge using long nose pliers.

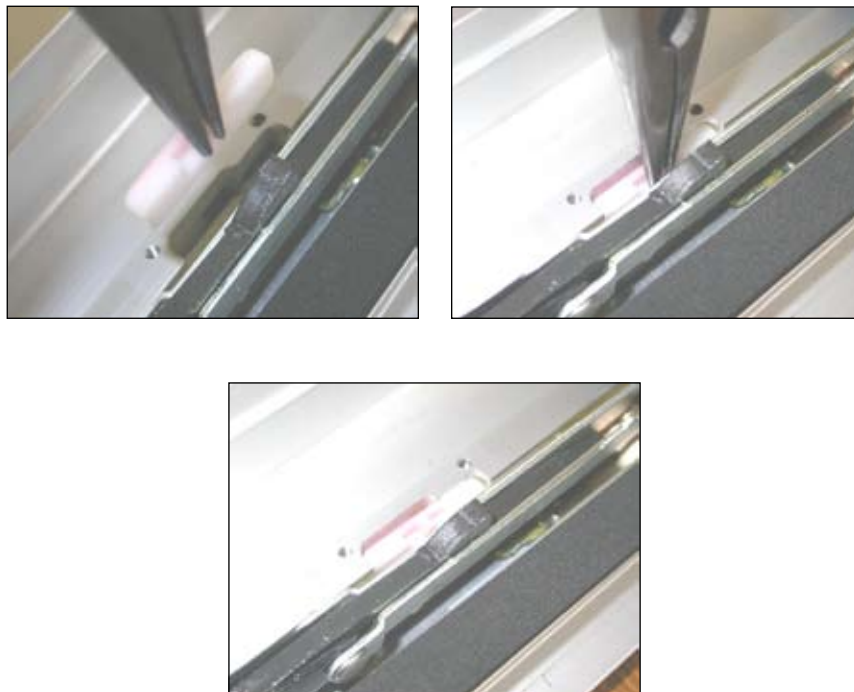
**Left side shown (cutaway of spacer faces sunroof opening)**
