## SERVICE BULLETIN

**APPLICABILITY:** 2010MY and Later Legacy & Outback  
 2012MY Impreza  
 2006MY and later Tribeca

**NUMBER:** 12-134-12

**SUBJECT:** Washer Fluid Level Sensor Diagnostics

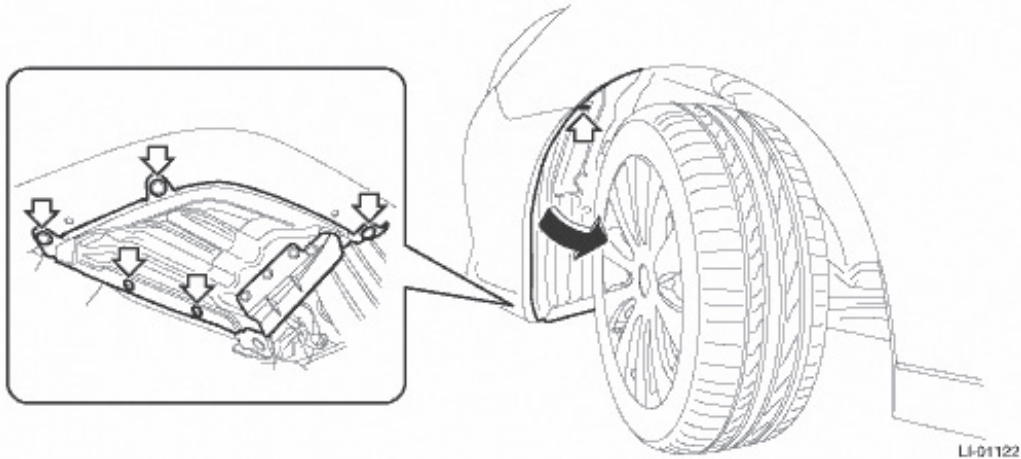
1. Release the retaining clips and lower the L/F splash guard to gain access to the washer fluid tank and fluid level sensor assembly.
