# SERVICE BULLETIN

**SUBARU CORPORATION**  
Customer Quality Dept.  
Japan.

Issued: Jun 8, 2023

| Subject: | <b>Release of Reprogramming Files (Ver. 12.0) for Gen4.0 CP1 (Cockpit Control Unit) 21-22MY OUTBACK</b> |

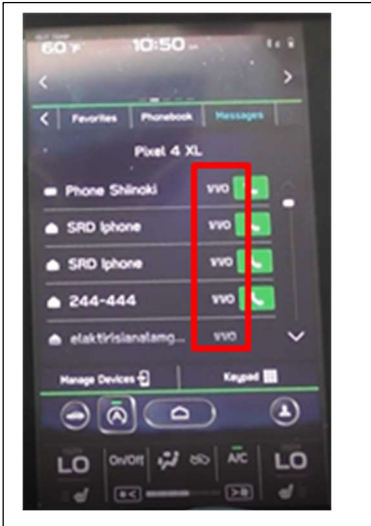
| No | Symptom to be improved | | | | | | | | | | |
|---|---|---|---|---|---|---|---|---|---|---|---|
| 20 | When selecting "Phone->"Message," message received time is displayed incorrectly as "1/1/0." | | | | | | | | | | |
| |

<p>It can occur with an Android phone with a specific Android OS (Pixel 6, Pixel4a, Pixel4XL, Xperia5 II ) in which time zone data is attached to the message receiving time.</p>                                                                                                                                                                                                                                              |                   |          |                             |                   |           |      |    |               |      |    |
| 21 | <p>Chines voice recognition command in screen is not recognized.</p> <p>Displayed Chinese command is not correct. Correct Chines command in screen.</p>

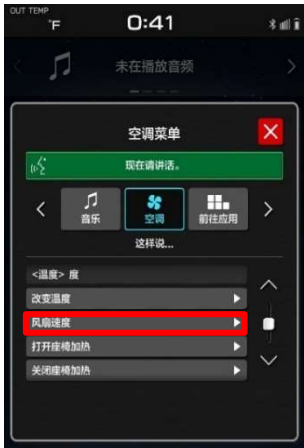
<table><tr> <th>Function</th><th>Incorrect Command in screen</th><th>Corrected Command</th></tr><tr> <td>Fan speed</td><td>风扇速度</td><td>风速</td></tr><tr> <td>Dial a number</td><td>拨打号码</td><td>拨打</td></tr></table>

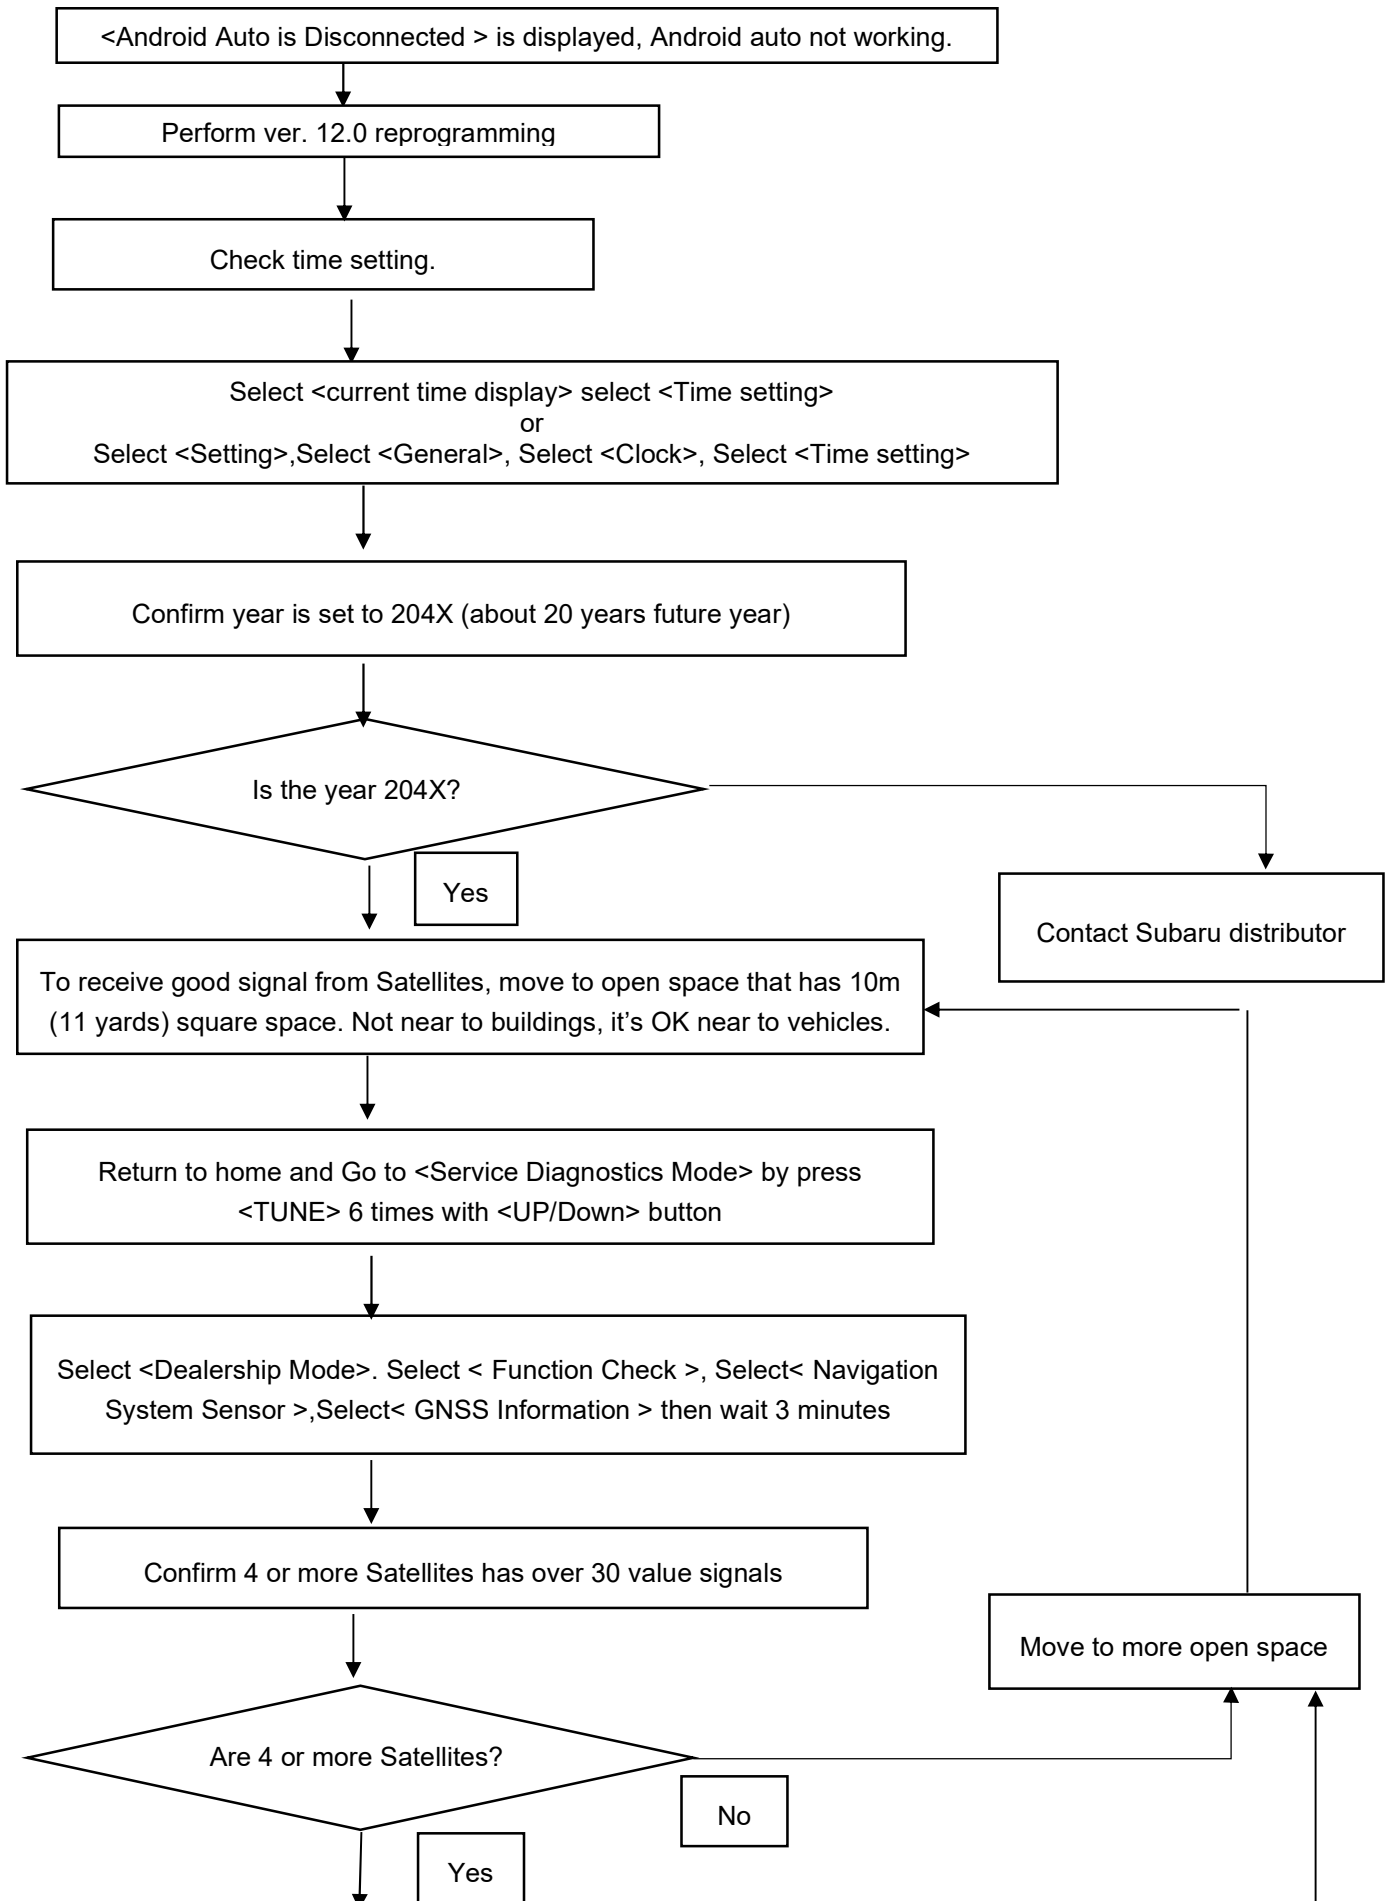
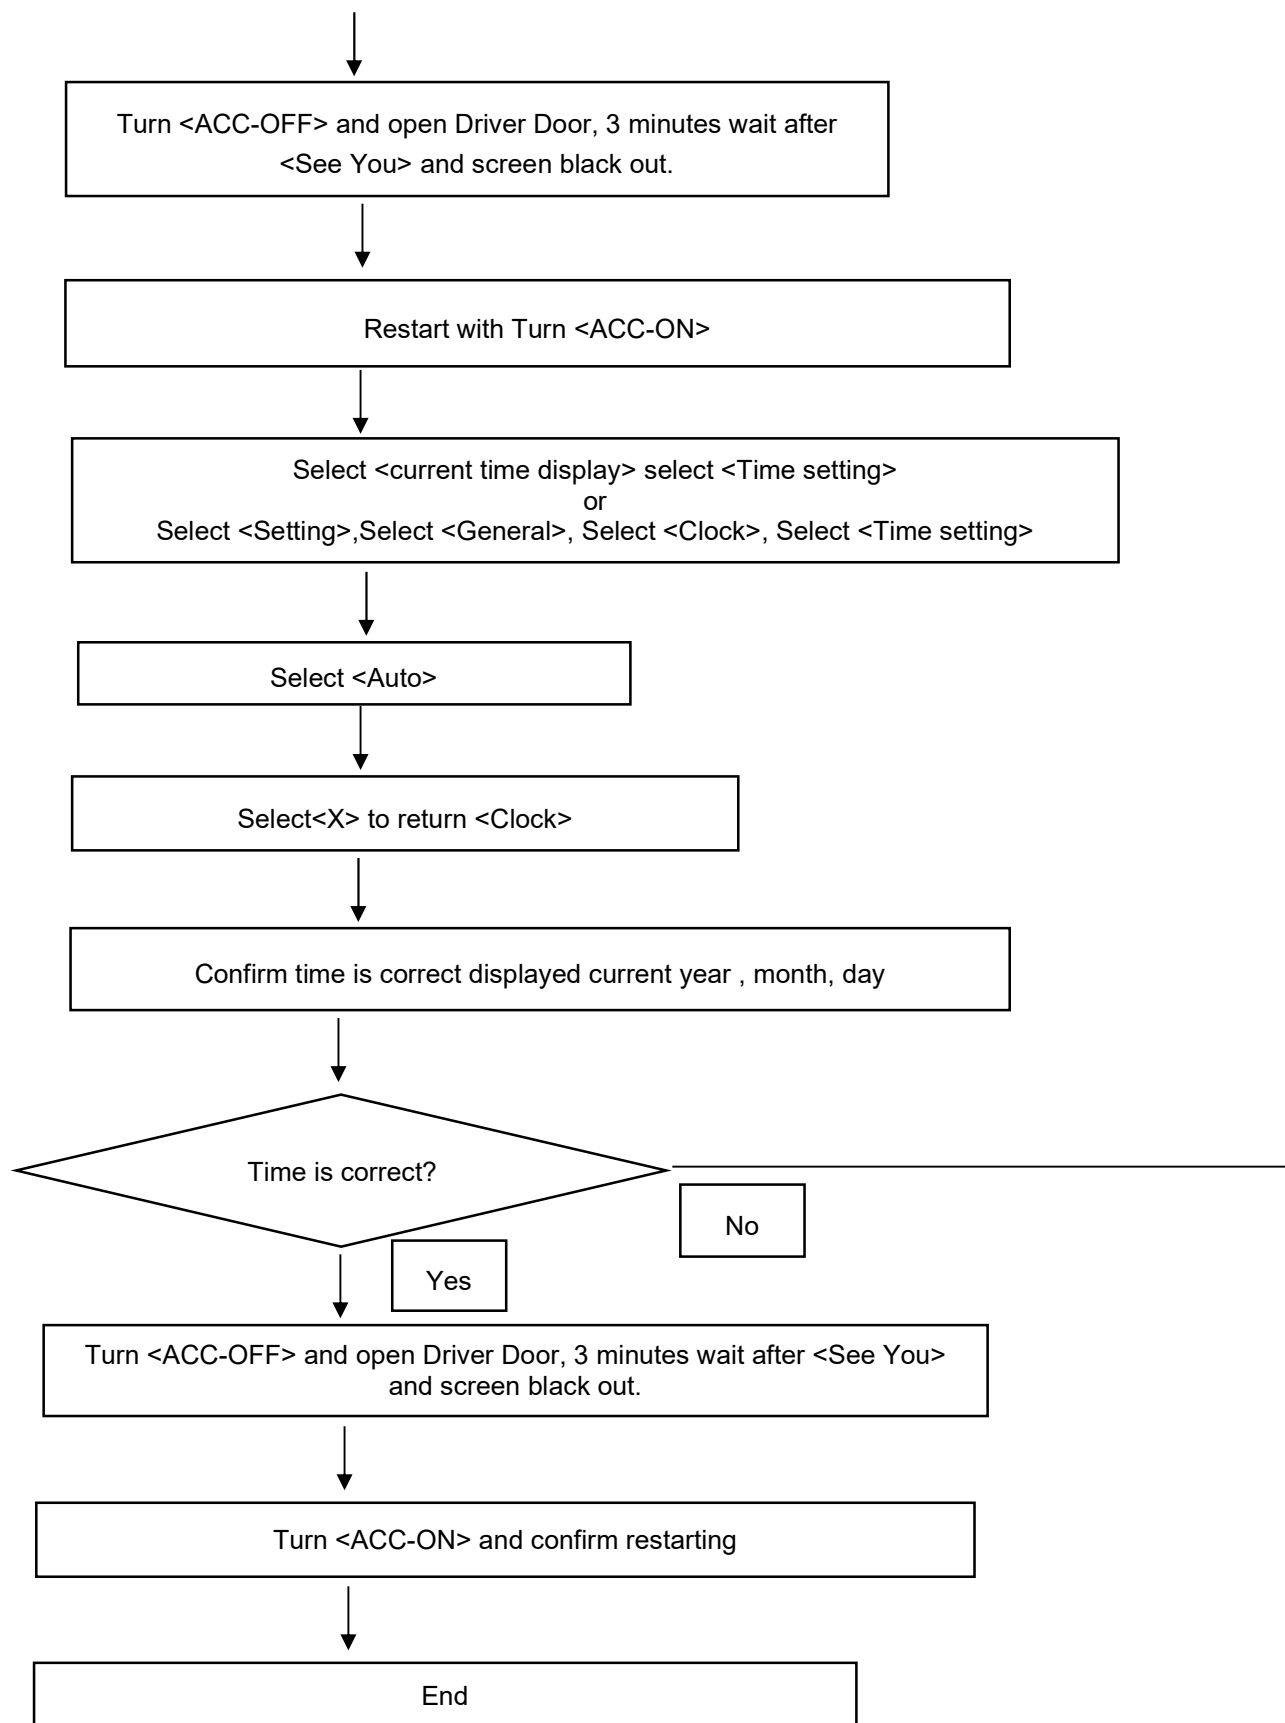
The following additional work procedures are required when the problem of Android Auto not working.(<Android Auto is Disconnected >is displayed).

Note: The time should be set with GPS. Time set by manual setting cannot solve this problem.

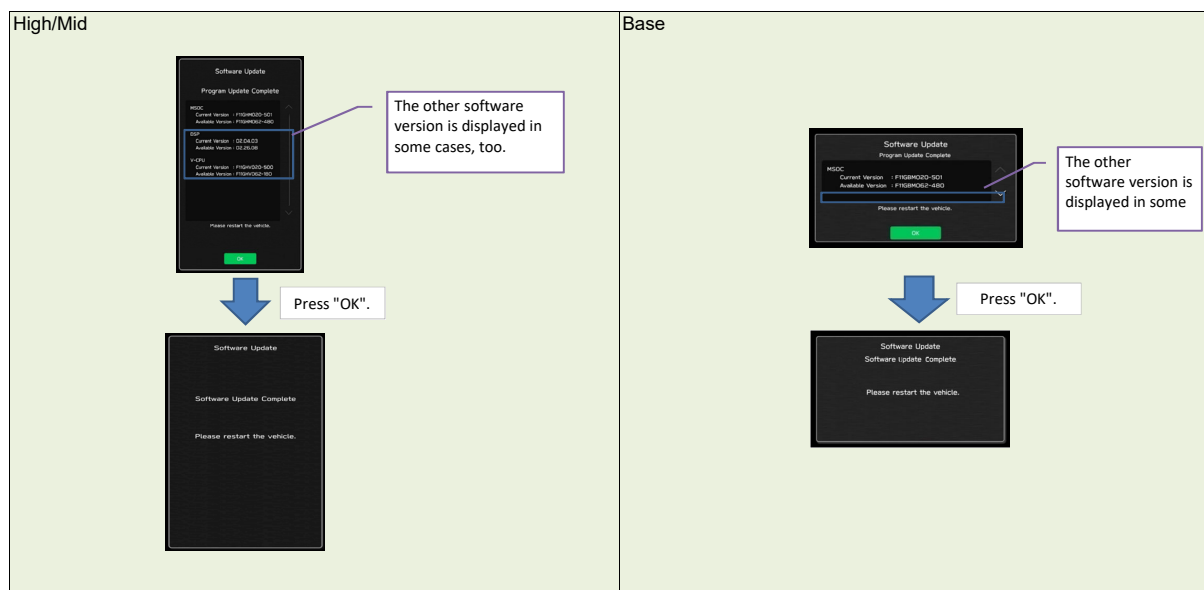
**If you see the <incomplete> error message in this step. There is rarely displayed due to a software defect.**

**Since the software update itself has been completed normally, check that the software version is the latest after step 9.**

9. Select OK in the screen above, then unplug the CCM repro USB from the USB port.
